TOOWOOMBA HOUSE INSPECTIONS & REPORTS

PRE-PURCHASE STANDARD PROPERTY REPORT

Report number: 1903012

Property address: 6 Large Street
Toowoomba

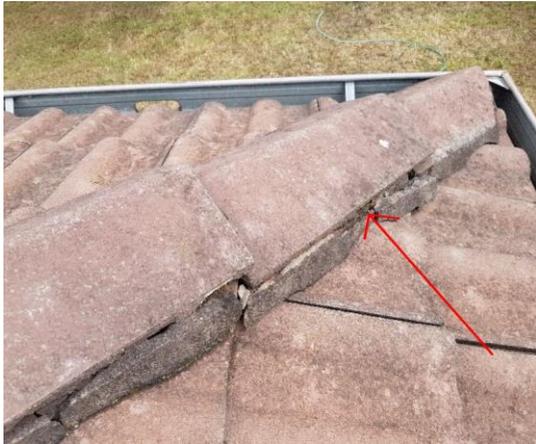
There's a large amount of the pointing on the capping tiles that has fallen out. It would be recommended to have a roof tiler repoint the ridge capping to maintain the integrity of the roof.

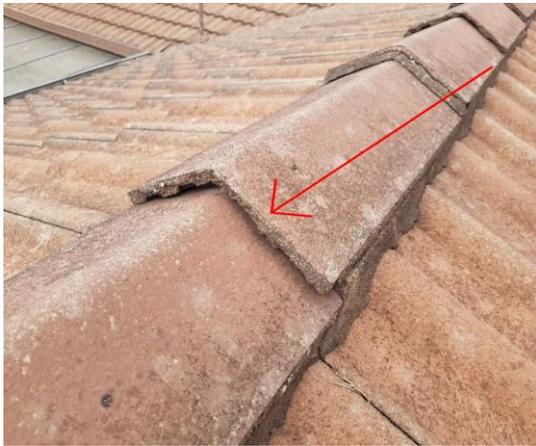
There's a large amount of the pointing on the capping tiles that has fallen out. It would be recommended to have a roof tiler repoint the ridge capping to maintain the integrity of the roof.

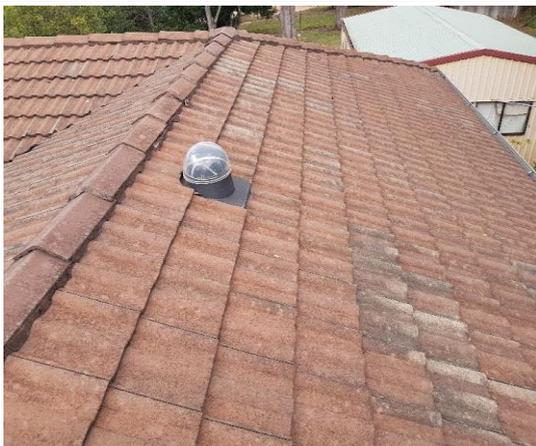
ROOF SHEETING-

The roof sheeting and gutters appears to be in a **SOUND** condition.

There is a moderate number of defects that is typical and normal for the age of the building that has not been maintained fully.

Ensure that the gutters are kept free of leaves and dirt. Periodically inspect the roof sheeting for any possible water leaks that may develop over a period of time.

It would be recommended to have a roof tiler restore and paint this roof.

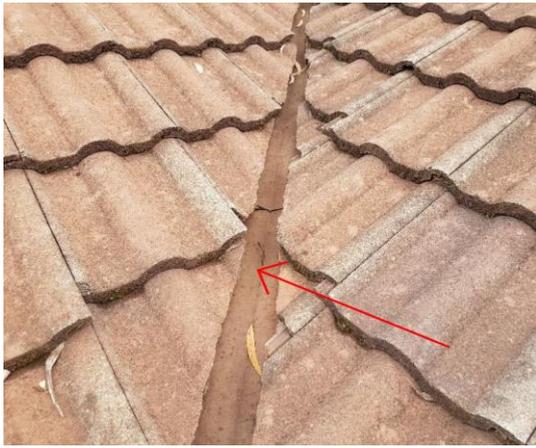
There is surface rust starting to develop in the valley irons. Eventually these Valley irons will need to be replaced

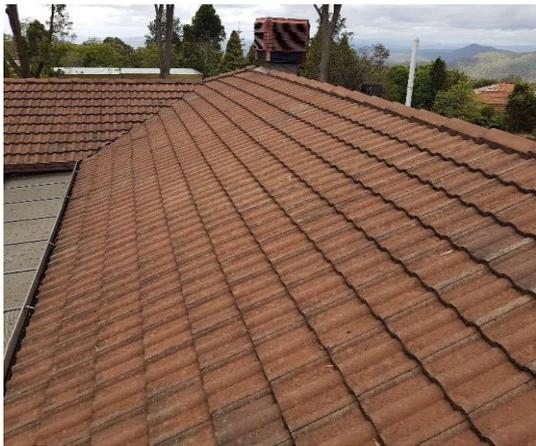
ROOF SHEETING-

The roof sheeting and gutters appears to be in a **SOUND** condition.

There is a moderate number of defects that is typical and normal for the age of the building that has not been maintained fully.

Periodically inspect the roof sheeting for any possible water leaks that may develop over a period of time.

It would be recommended to have a roof tiler restore and paint this roof.

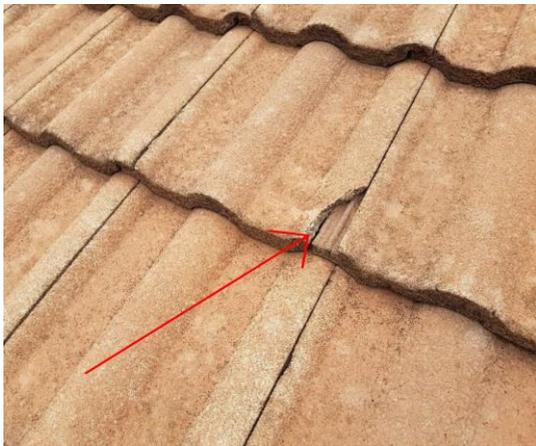
There are a number of roof tiles that have broken on the front edge of the tile. These tiles are still water tight but would still recommend to have them replaced to maintain the Integrity of the roof.

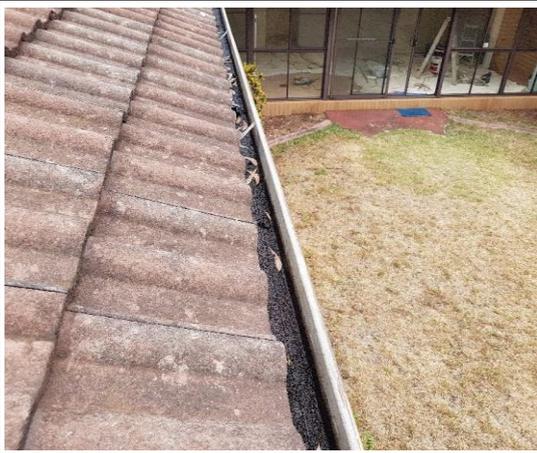
The majority of the roof gutters have surface rust or are rusting through. It would be recommended to have the gutters replaced in the near future.

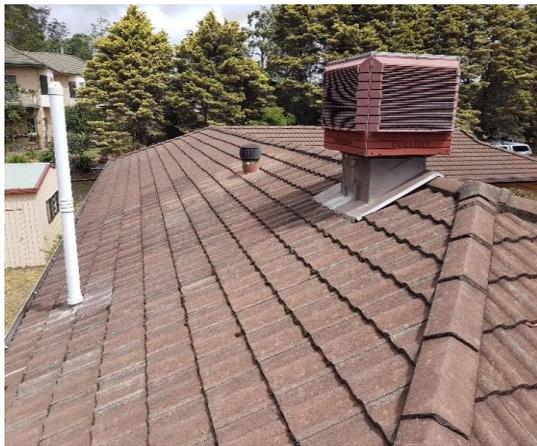
ROOF SHEETING-

The roof sheeting and gutters appears to be in a **SOUND** condition.

There is a moderate number of defects that is typical and normal for the age of the building that has not been maintained fully.

Periodically inspect the roof sheeting for any possible water leaks that may develop over a period of time.

It would be recommended to have a roof tiler restore and paint this roof.

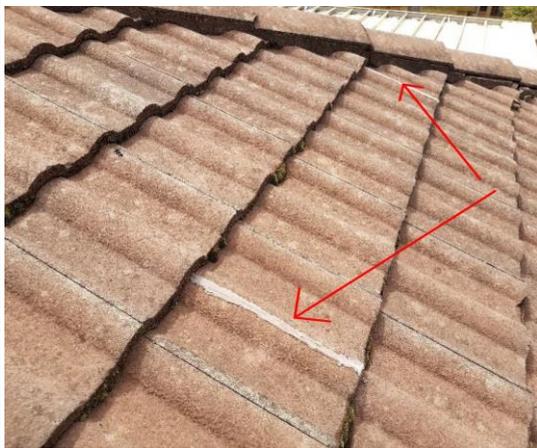
There are several roof tiles that have been broken and repaired by using silicone. It would be recommended to have these roof tiles replaced. Seek further advice from a roofing contractor.

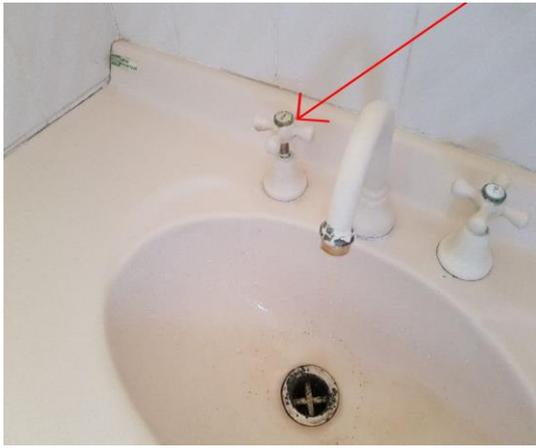
The hot water tap to the vanity basin in the bathroom is constantly leaking and will need to be repaired by a plumber.

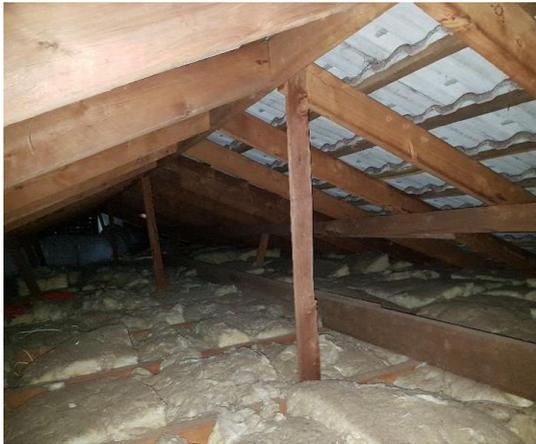
ROOF CAVITY CYPRESS-

The roof cavity appears to be in a SOUND AND GOOD condition.

Cypress Pine is a Termite resistant timber that would be eaten by Termites should they gain access to the Building. Please note that there will be other types of timber species in the house that Termites will eat if they were to gain access into the house, e.g. door frames, mouldings and plasterboard. See pest report for more detail.

Periodically inspect the ceiling cavity for any possible water leaks and maintenance repair work that maybe required over a period of time.

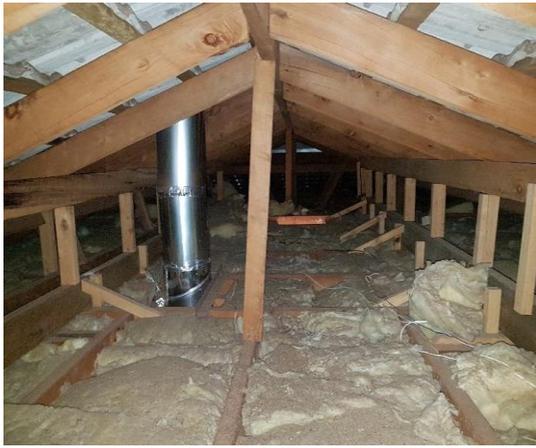
ROOF CAVITY CYPRESS-

The roof cavity appears to be in a SOUND AND GOOD condition.

Cypress Pine is a Termite resistant timber that would be eaten by Termites should they gain access to the Building. Please note that there will be other types of timber species in the house that Termites will eat if they were to gain access into the house, e.g. door frames, mouldings and plasterboard. See pest report for more detail.

Periodically inspect the ceiling cavity for any possible water leaks and maintenance repair work that maybe required over a period of time.

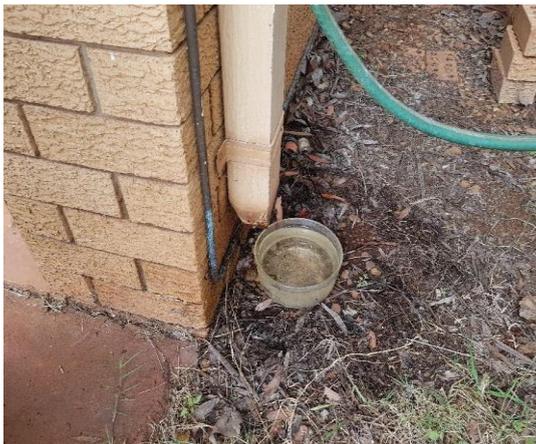
DOWN PIPES-

The down pipes on the external walls are discharging at the base of the house.

Water lying against the house can cause problems with the footing system and lead to possible movement within the house causing cracking to plaster work and brick work.

Moisture near the building can attract Termites to the house area as they require moisture to survive.

It would be recommended to extend the down pipe away from the house by at least 3 meters, so surface water does not flow back towards the building.

See a Plumber to rectify.

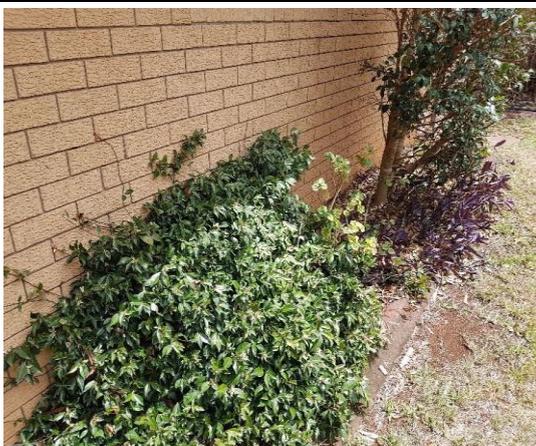
TREES-

There are trees and shrubs around the house. It would be highly recommended to remove the trees or shrubs away from the building.

Their root system can cause movement to the footing system. This can cause cracking to the plasterboard and brick work within the house.

Having plants and trees near the house can also attract Termites into the building and obstruct visual inspection of the external walls.

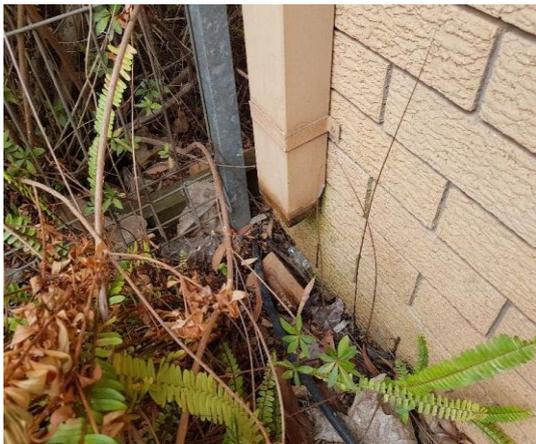
DOWN PIPES-

The down pipes on the external walls are discharging at the base of the house.

Water lying against the house can cause problems with the footing system and lead to possible movement within the house causing cracking to plaster work and brick work.

Moisture near the building can attract Termites to the house area as they require moisture to survive.

It would be recommended to extended the down pipe away from the house by at least 3 meters, so surface water does not flow back towards the building.

See a Plumber to rectify.

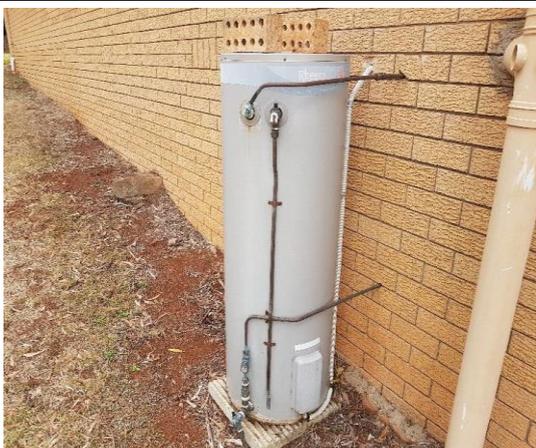
HOT WATER SYSTEM-

The Hot water system appears to be in a FAIR condition for the age of the unit.

Note- The average age of a Hot water system if maintained is 15 to 18 years. After this time frame, the unit may need to be replaced. This is to be done by a Plumber.

Confirm the working condition of the unit with a Plumber or service agent.

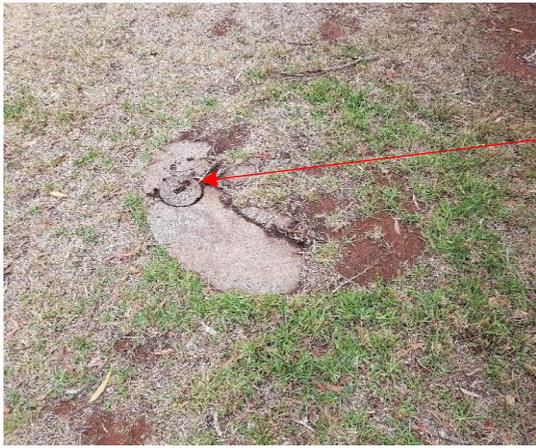
The concrete baffle that is on the outlet side pipe inside the tank has eroded away. This is going to require a plumber to install pipe inside the tank.

The concrete baffle has been eroded away for a considerable amount of time. There is a possibility that there could be blockages to the evaporation pit. Seek further advice from a plumber.

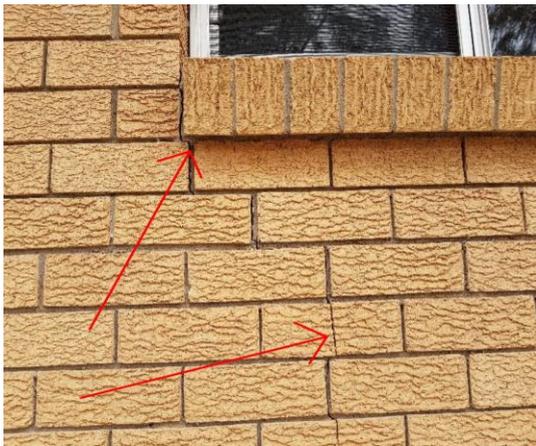
There is movement cracking to the brickwork at the rear of the house. This pregnant is most likely caused from dry weather conditions in the soil subsiding.

It would be recommended to install an expansion joint in brickwork to control any further cracking. There is a possibility that this crack could become wider in the future. Should ask crack become wider in the future it would be recommended to have an engineer inspect

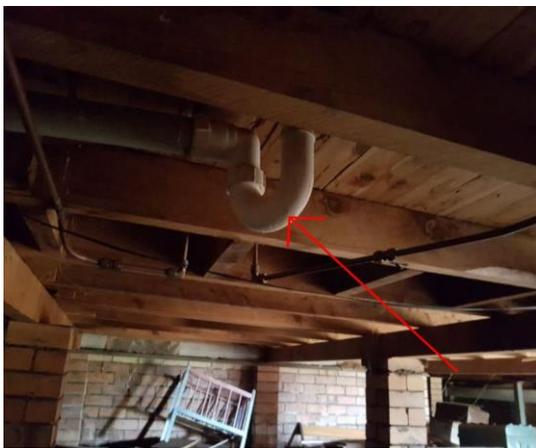
there is a small washing leak to the drain pipe under the bathroom. This will need to be repaired on a plumber.

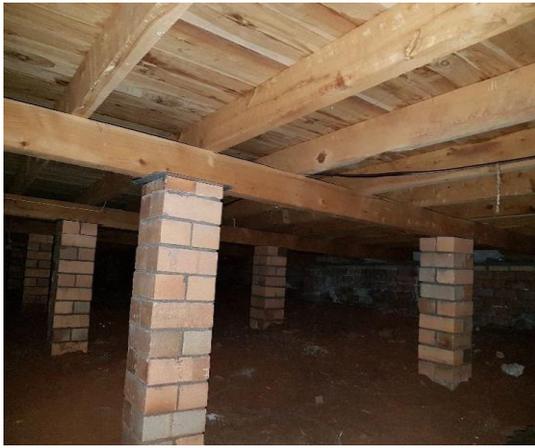
SUB FLOOR-

The sub floor appears to be in a SOUND condition at the time of the inspection.

There are some normal and minor defects. These defects are typical for the age of the house.

Monitor and ensure that surface rain water does not flow under the building as this can cause issues with movement to the Piers and can cause movement to the Building.

Have the plumbing pipes and drains regularly inspected for possible water leaks that may occur.

It would be recommended to have annual Termite inspections carried out. See pest report for more details.

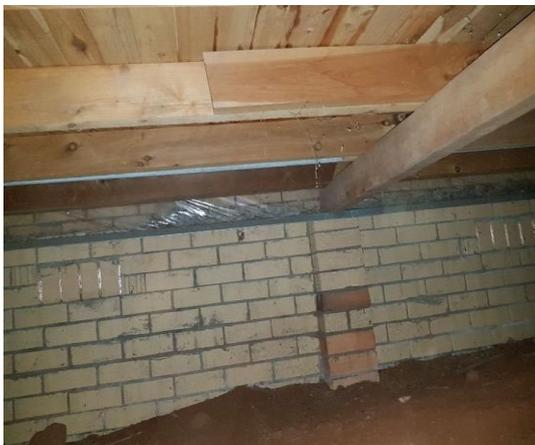
SUB FLOOR-

The sub floor appears to be in a SOUND condition at the time of the inspection.

There are some normal and minor defects. These defects are typical for the age of the house.

Monitor and ensure that surface rain water does not flow under the building as this can cause issues with movement to the Piers and can cause movement to the Building.

Have the plumbing pipes and drains regularly inspected for possible water leaks that may occur.

It would be recommended to have annual Termite inspections carried out. See pest report for more details.

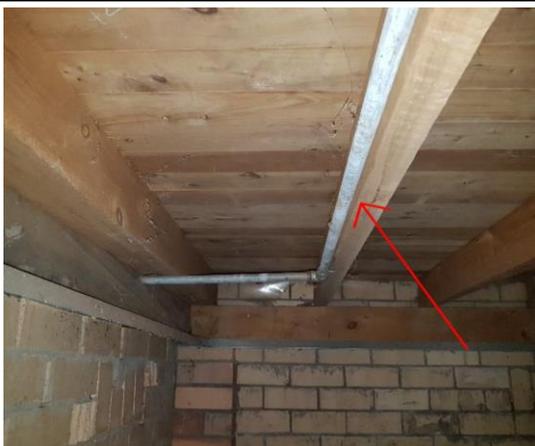
GALVANISED PIPES-

Some of the waste and water pipes under the floor from the Bathroom and Kitchen are "Galvanised pipes".

In time the Galvanised pipes will eventually rust and reduce in diameter size which will prevent water from flowing through the pipe. When this does occur, the water pressure will become slow or the waste water will drain away slowly.

It is not possible to tell when this will occur without pulling the pipes apart and inspecting.

The rusting pipes will have to be replaced with either PVC or Copper pipe.

Seek advice from a Plumber.

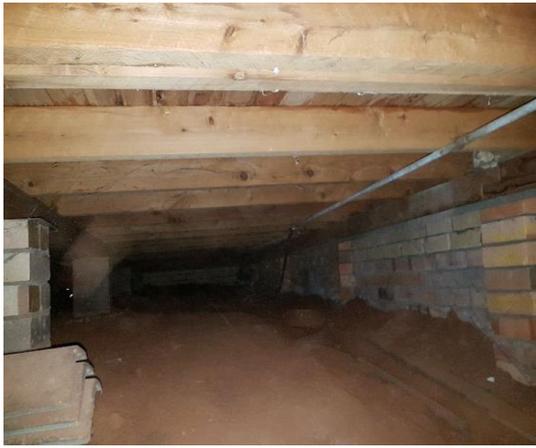
SUB FLOOR-

The sub floor appears to be in a SOUND condition at the time of the inspection.

There are some normal and minor defects. These defects are typical for the age of the house.

Monitor and ensure that surface rain water does not flow under the building as this can cause issues with movement to the Piers and can cause movement to the Building.

Have the plumbing pipes and drains regularly inspected for possible water leaks that may occur.

It would be recommended to have annual Termite inspections carried out. See pest report for more details.

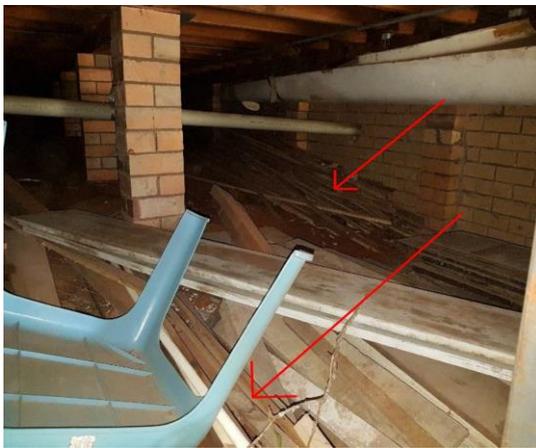
Removed the unwanted building material away from under the house. This can attract termites to the area.

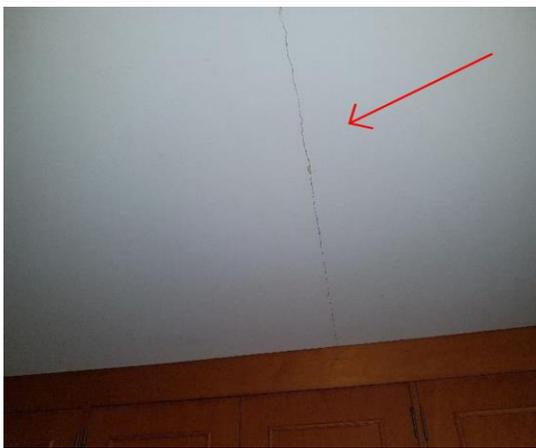
CRACKS TO PLASTERBOARD-

There are several minor hairline movement cracks to the plasterboard ceiling and walls.

This is a very common occurrence for a house to develop small hairline cracks.

This is caused by very small amounts of movement within the building caused from soil movement or timber movement,

These areas can be repaired by a Plasterer and Painter if required.

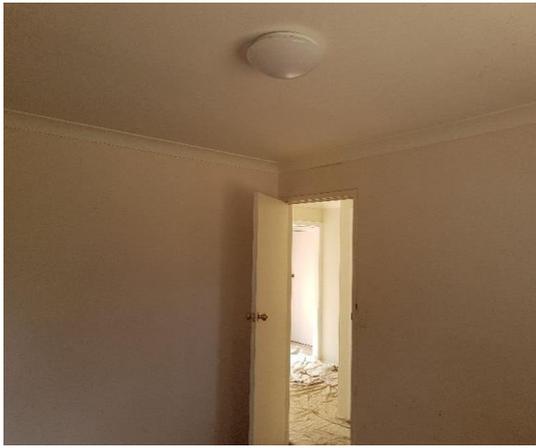
WEAR AND TEAR-

There are wear and tear marks throughout the building that is to be expected for the age of the building. This can include minor dents to the walls, hairline cracks to the plasterboard walls and ceilings, dirt marks, ect throughout the building on the internal walls and ceiling. This is FAIR for a house of this age that has been lived in. Not all defects have been noted in the report due to being minor defects.

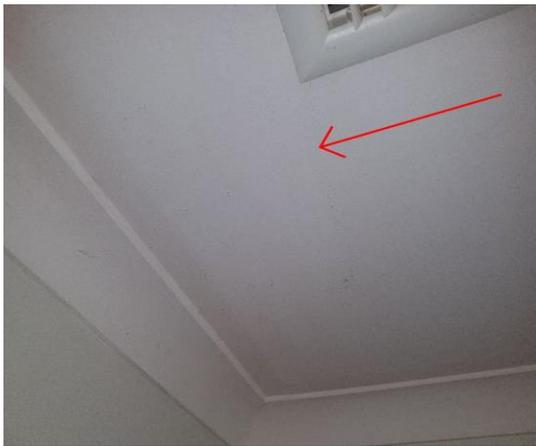
There are a number of areas in the bedrooms where the paintwork is flaking on the ceiling.

These areas can be repaired by a painter.

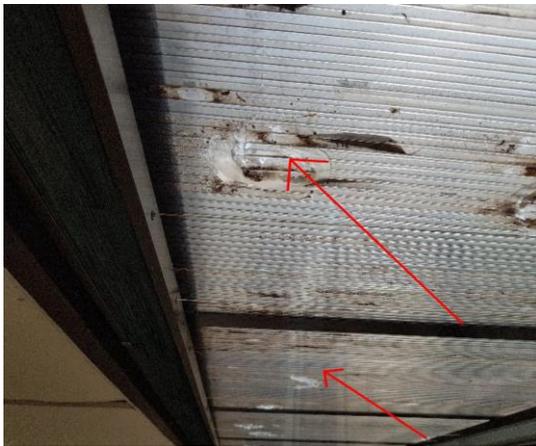
The polycarbonate roof sheeting over the front sunroom is in a poor condition as it has had hail damage in the past. These holes have been filled with silicone. It would be recommended to have this roof sheeting replaced.

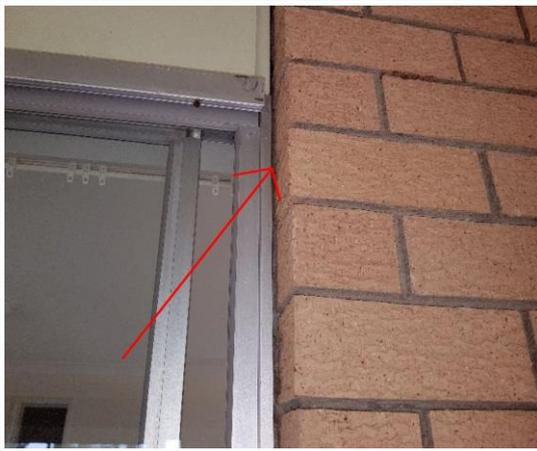
There are a couple of windows where the brickwork has pulled away from the aluminium window frame. This is caused from subsidence within the building and the brickwork has moved slightly. There did not appear to be any significant structural issues at the time of the inspection but these areas will need to be monitored possible further movement. Should these gaps be noticed to be getting wider it would be recommended to have an engineer inspect and repair work carried out.

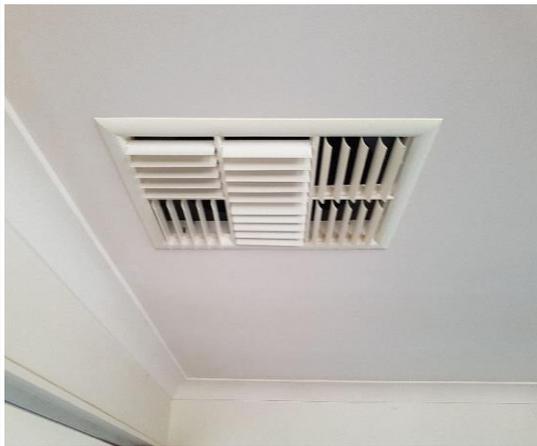
The evaporative air cooler did start at the time of the inspection but was not tested to its full capacity. It would be recommended to have a service agent inspect and test.

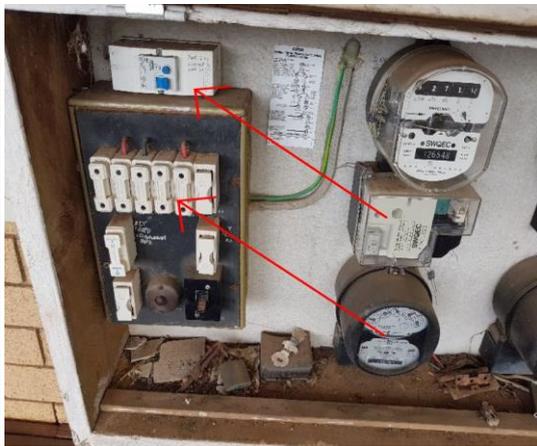
CERAMIC FUSES-

The meter box does have an RCD safety switch. The safety switch was not tested at the time of the inspection. Basic testing was carried at the time of the of the inspection but it is recommended to have an Electrician inspect and report on the electrical wiring, power points, lights and appliances to the house to confirm .

The meter box still has old style ceramic fuses installed that were used in the era when the house was originally built. These fuses are still compliant, but it would be **SUGGESTED** to update the fuses. These ceramic fuses can be exchanged with circuit breaker fuses that do not use a fuse wire that are easily reset should the circuit breaker trip and turn off.

This should easily be able to be installed by an Electrician. It is recommended to test the RCD safety switch every month.

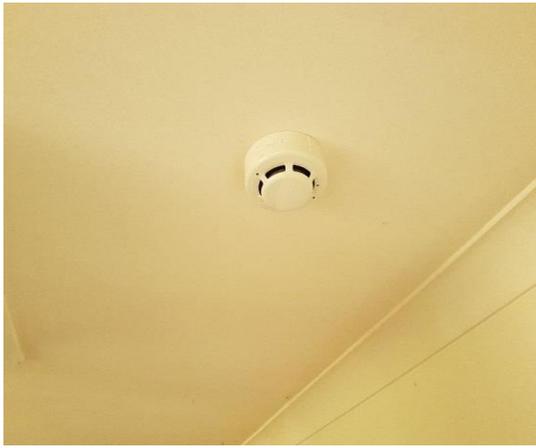
SMOKE ALARM-

The smoke alarms are over 10 years old and will need to be replaced. Seek further advice from an electrician.

New smoke alarm rules started January 2017. Smoke alarms must be replaced once they are 10 years old with a Photo Electric type smoke alarm. Ensure that the Bedrooms do have a smoke alarm outside in the Hallway protecting the room from possible fires from the Kitchen area.

Seek further advice from an Electrician or visit www.qfes.qld.gov.au for more details.

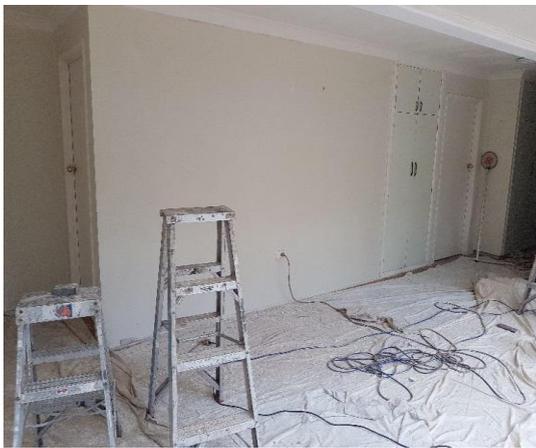
There was painting being carried out at the time of the inspection that was yet to be completed.

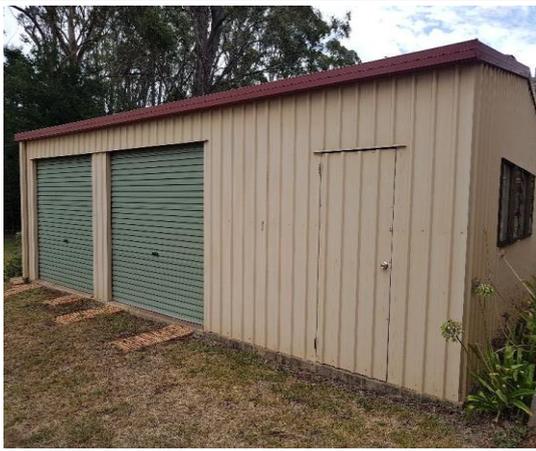
The shed was only inspected from the outside. The shed appears to be structurally sound and in a good condition from what could be seen.
