**Report No: 36064**

## **PRE-PURCHASE TIMBER PEST DETECTION REPORT**

ADDRESS OF PROPERTY INSPECTED : **7 Kinnoull Terrace**

**RANGEVILLE 4350**

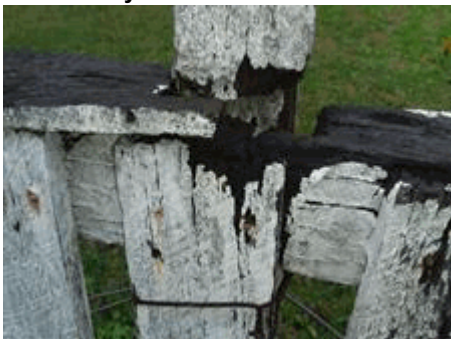
Was evidence of Fungal Decay found? **Yes - see Details below, Clauses A.5 and A.8 - Decay noted to fencing. Monitor and replace as necessary.**

**- Decay noted to front corners under gutters.**

The condition of the timber appears: **Decaying - see Details below, Clauses A.5 and A.8**

The extent of any visible damage appears: **Localised - see Details below**

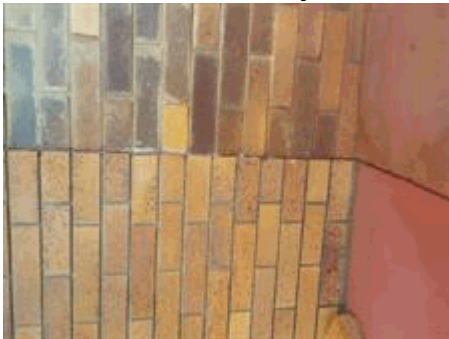
**Steps/Ramps - Brick steps joined to house may conceal termite activity. Additional Slab - Joint in slab may conceal termite activity.**

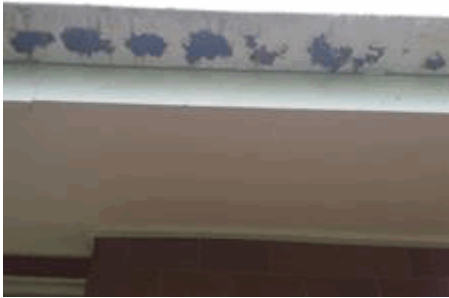
Was evidence of any other condition conducive to timber pest attack found? **Yes - see Details below, Clauses A.7 and A.8 - Gutters are rusted and leaking which can cause moisture to build up and can attract termites to the area. Recommend repairing or replacing.**

**- Timber in subfloor is termite susceptible and should be removed.**
