# TOOWOOMBA HOUSE INSPECTIONS & REPORTS

## PRE-PURCHASE STANDARD PROPERTY REPORT

Report number: 1905012

Property address: 92 Lindsay Street  
Toowoomba

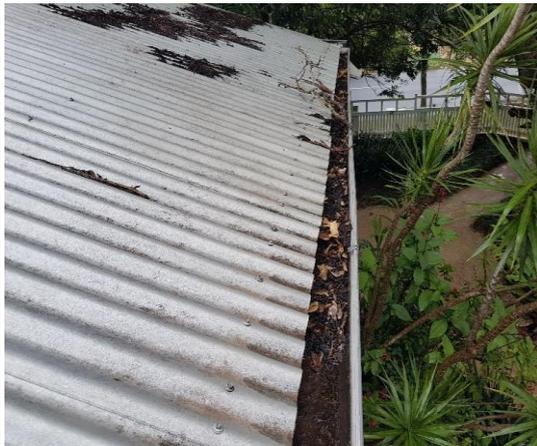
**LEAVES IN GUTTERS-**

The roof gutters to the building have leaves and dirt laying inside the gutters.

The gutters and valley iron will need to be kept clean to stop possible rusting occurring. This will allow the rain water to be able to flow away via the down pipes without overflowing the gutters.

This will be an ongoing maintenance job that will need to be monitored.

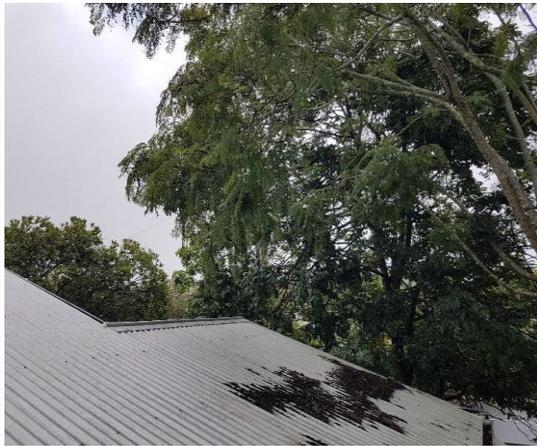
**SHRUB BRANCHES-**

There are shrub or tree branches growing near or over the roof. These branches will need to be removed as they will be putting leaves into the gutters. This can cause the gutters to rust as well as other building issues.

Seek advice from a competent person.

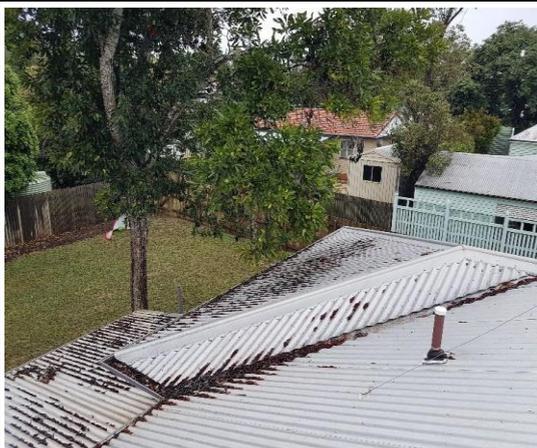
**LEAVES IN GUTTERS-**

The roof gutters to the building have leaves and dirt laying inside the gutters.

There are shrub or tree branches growing near or over the roof. These branches will need to be removed as they will be putting leaves into the gutters. This can cause the gutters to rust as well as other building issues.

The gutters and valley iron will need to be kept clean to stop possible rusting occurring. This will allow the rain water to be able to flow away via the down pipes without overflowing the gutters.

Seek advice from a competent person.

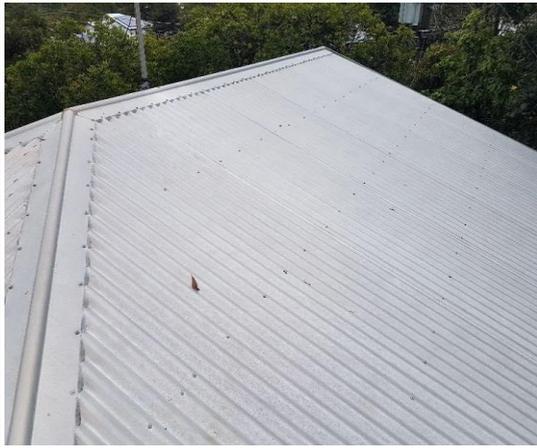
**ROOF SHEETING-**

The roof sheeting and gutters appears to be in a **SOUND** condition.

There are some minor defects that is typical and normal for the age of the building.

Ensure that the gutters are kept free of leaves and dirt.

Periodically inspect the roof sheeting for any possible water leaks that may develop over a period of time.

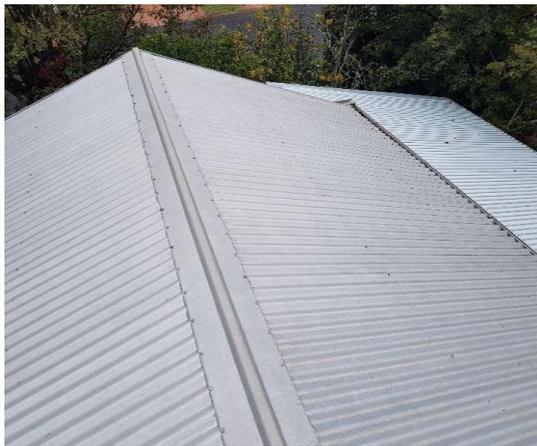
**ROOF SHEETING-**

The roof sheeting and gutters appears to be in a **SOUND** condition.

There are some minor defects that is typical and normal for the age of the building.

Ensure that the gutters are kept free of leaves and dirt.

Periodically inspect the roof sheeting for any possible water leaks that may develop over a period of time.

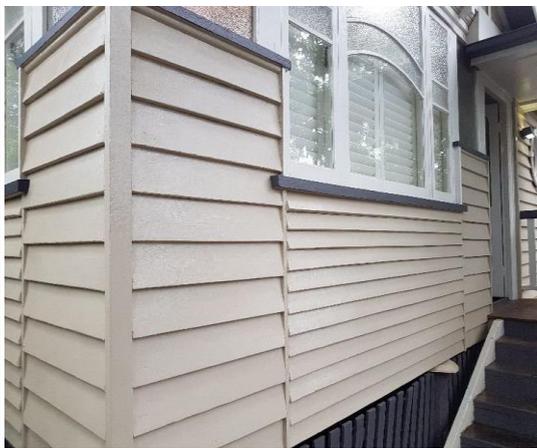
The weather boards on the outside of the building appear to be structurally sound and in a good condition.

There are a couple of minor areas that have dry rot and may eventually require repairing or replacing.

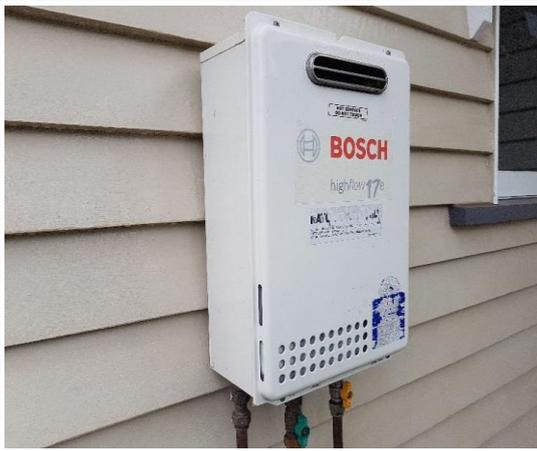
#### HOT WATER SYSTEM-

The Hot water system appears to be in a GOOD condition for the age of the unit.

Confirm the working condition of the unit with a Plumber or service agent.

Note- The average age of a Hot water system if maintained is 15 to 18 years. After this time frame, the unit may need to be replaced. This is to be done by a Plumber.

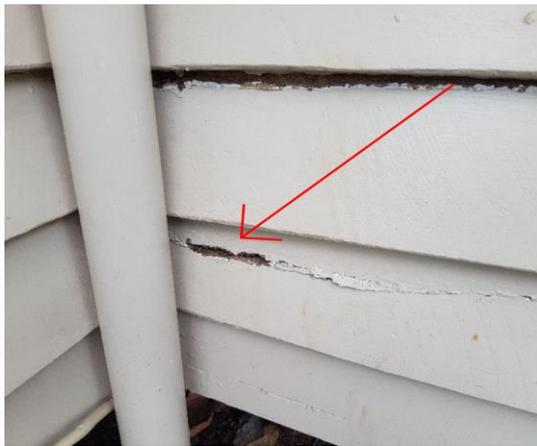
#### DRY ROT-

There were a couple of minor areas that have dry rot on timber mouldings, Facia boards or weather boards to the outside of the house.

This is caused by moisture seeping into the timber over a long period of time and is most likely caused from poor painting standards.

Monitor these areas and repair as necessary.

This can normally be fixed by a Carpenter and a Painter.

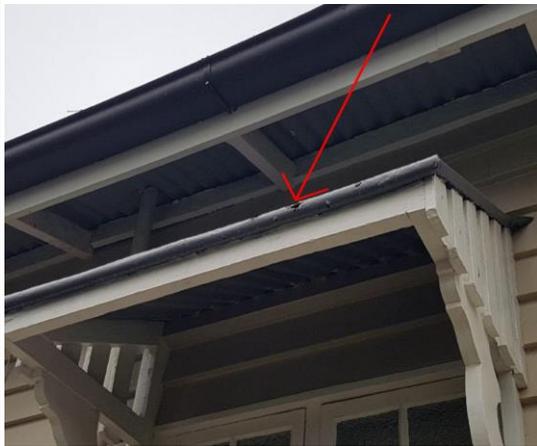
The Gable roll on several of the window hoods have rusted and will need to be replaced.

This is a maintenance issue. Seek further advice from a roofing contractor.

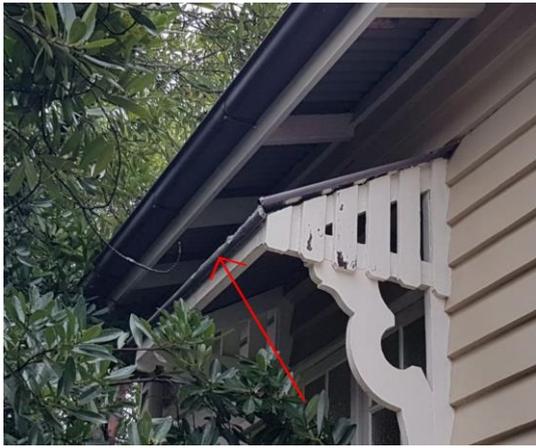
The Gable roll on several of the window hoods have rusted and will need to be replaced. This is a maintenance issue. Seek further advice from a roofing contractor.

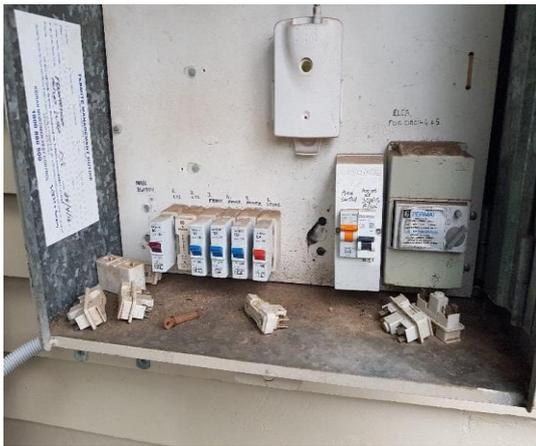
#### SWITCH BOARD-

The switch board appears visually to be of a compliant standard. The RCD safety switch was not tested at the inspection. Basic testing was carried out at the time of the inspection but it would be recommended to have an electrician inspect to confirm the condition of the meter box, power points, lights, appliances and electrical wiring to the house. It would be recommended to test the RCD safety switch every month to ensure it is working correctly.

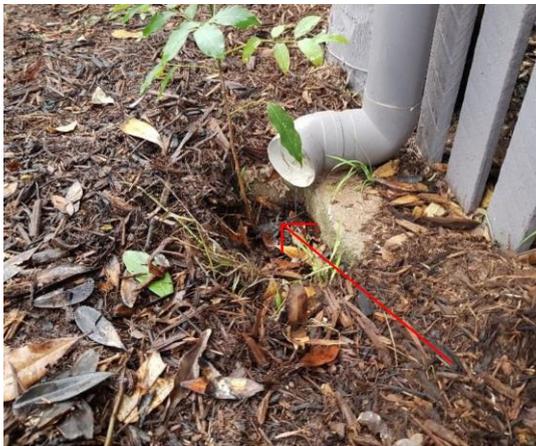
The storm water drain for the downpipe appears to be blocked with garden mulch. This will need to be cleared away.

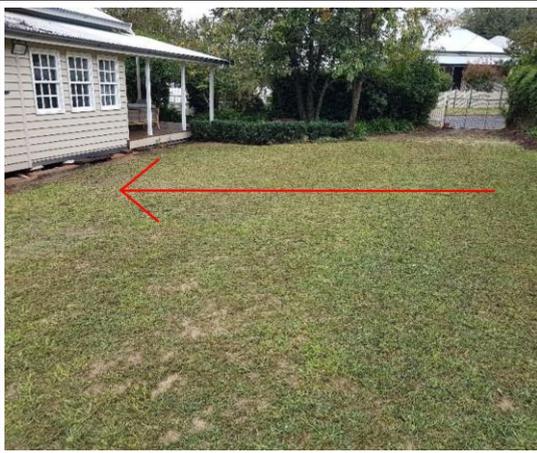
#### WATER FLOW-

Monitor and ensure rain surface water does not pond against or flow under the building. During rainy conditions, monitor and observe around the building and inspect to see that water is flowing away and not towards the house. Divert the water away if this does occur via installing drain pipes or constructing dirt culverts. Seek further advice of a Plumber or Builder.

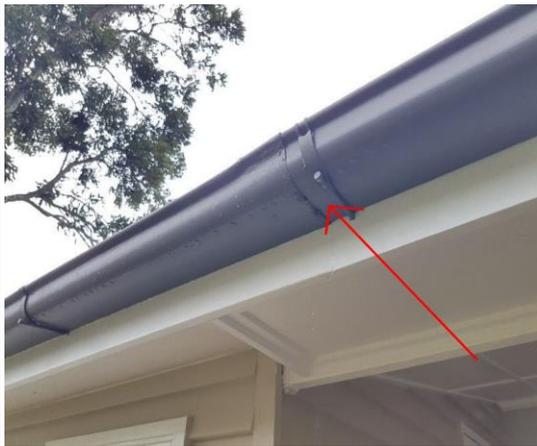
The gutter at the rear of the house is leaking on the joint and will need to be resealed with silicone.

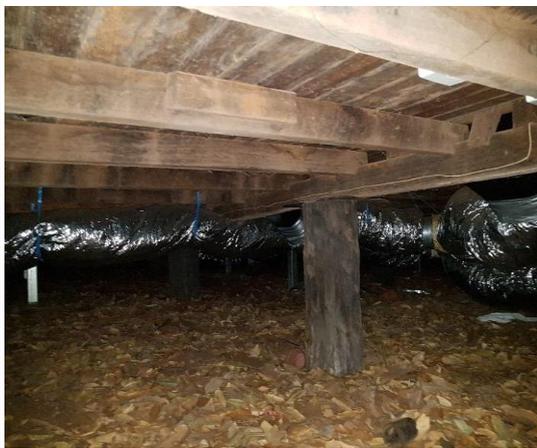
#### SUB FLOOR-

The sub floor appears to be in a SOUND condition at the time of the inspection. There are some normal and minor defects. These defects are typical for the age of the house. Monitor the sub floor area for any issues that may arise over a period of time. Monitor and ensure that surface rain water does not flow under the building as this can cause issues with movement to the Piers and can cause movement to the Building. Have the plumbing pipes and drains regularly inspected for possible water leaks that may occur.

If the house has Timber house stumps and is older style house, it would be recommended to have a house restumper inspect and confirm the condition of the timber stumps for possible rotting to the timber below ground level.

It would be recommended to have annual Termite inspections carried out. See pest report for more details.

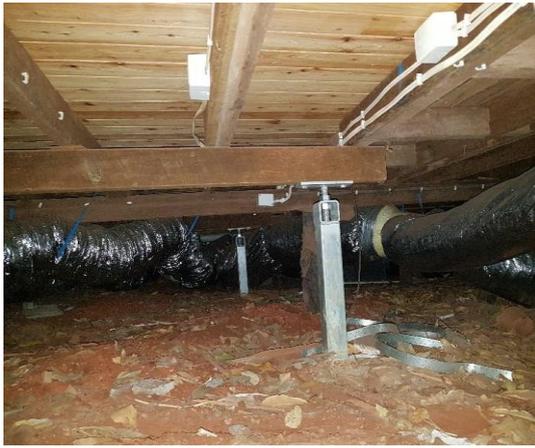
#### SUB FLOOR-

The sub floor appears to be in a SOUND condition at the time of the inspection.

There are some normal and minor defects. These defects are typical for the age of the house.

Monitor and ensure that surface rain water does not flow under the building as this can cause issues with movement to the Piers and can cause movement to the Building.

Have the plumbing pipes and drains regularly inspected for possible water leaks that may occur.

If the house has Timber house stumps and is older style house, it would be recommended to have a house restumper inspect and confirm the condition of the timber stumps for possible rotting to the timber below ground level.

It would be recommended to have annual Termite inspections carried out. See pest report for more details.

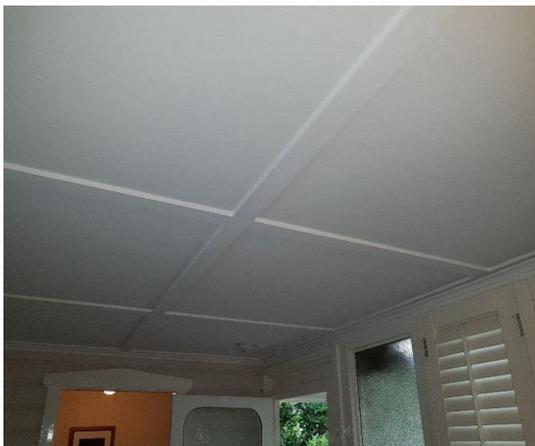
#### ASBESTOS-

The fibro sheeting to several areas to the building may possibly contain Asbestos particles.

Asbestos fibro is safe when it is in situ as long as it is kept painted and not broken or sanded that can in any way make the fibres airborne and able to be breathed in. The dust particles from asbestos can be harmful to your health if breathed in.

If the Fibro is to be removed it is recommended to have a person that is trained in removal of asbestos to carry out the work.

Seek further advice from a Licenced person.

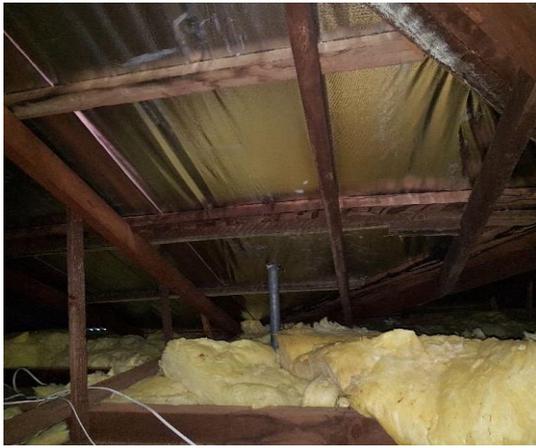
#### ROOF CAVITY PINE-

The roof cavity appears to be in a SOUND AND GOOD condition for the age of the building.

Periodically inspect the ceiling cavity for any possible water leaks and maintenance work that maybe required.

Pine Timber is a timber that Termites will eat if they gain access into the house. It is very important that the Termite management plan is kept up to date. See pest report for more detail.

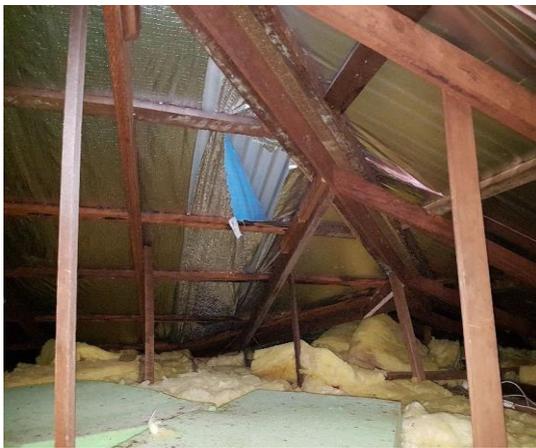
#### ROOF CAVITY PINE-

The roof cavity appears to be in a SOUND AND GOOD condition for the age of the building.

Periodically inspect the ceiling cavity for any possible water leaks and maintenance work that maybe required.

Pine Timber is a timber that Termites will eat if they gain access into the house. It is very important that the Termite management plan is kept up to date. See pest report for more detail.

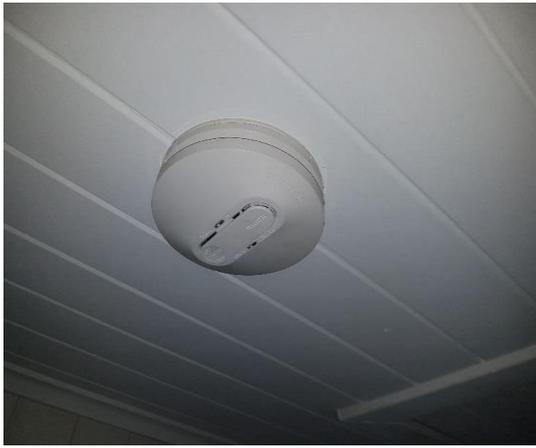
#### SMOKE ALARM-

New smoke alarm rules started January 2017. Smoke alarms must be replaced once they are 10 years old with a Photo Electric type smoke alarm. Ensure that the Bedrooms do have a smoke alarm outside in the Hallway protecting the room from possible fires from the Kitchen area.

Test smoke alarms before moving in to make sure that the alarms are working correctly and have new Batteries installed.

Seek further advice from an Electrician or visit [www.qfes.qld.gov.au](http://www.qfes.qld.gov.au) for more details.

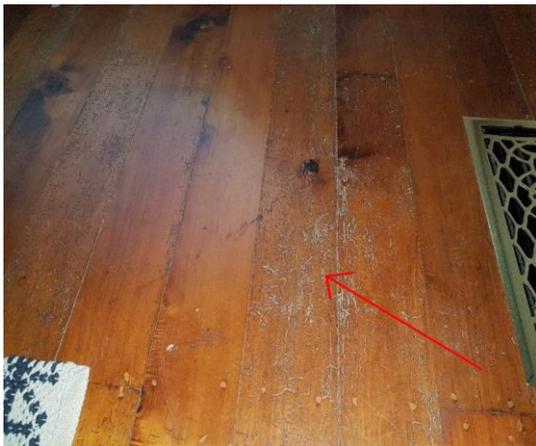
#### BORERS-

There is some moderate Borer damage to the timber floor boards to areas inside the house.

A Borer is a very small insect that lives in timber. They are not aggressive like Termites but if left untreated will do damage to floor boards that will need to be repaired. Some of these floor boards may need to be supported from under the floor by screwing timber to the affected board so they do not break if weight is placed on that particular board. This can easily be repaired by a competent person. It could be possible some of these boards that have very excessive Borer damage may need to be replaced. Seek advice from the Pest Inspector for more details.

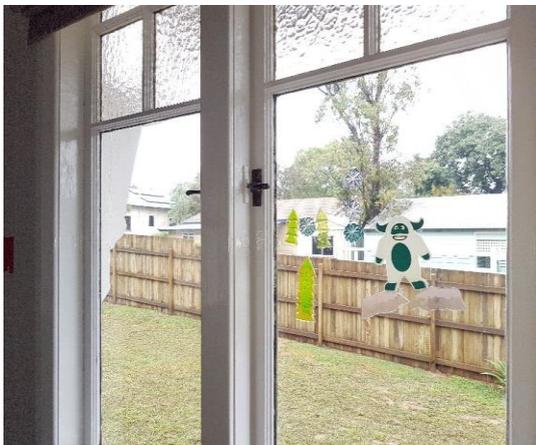
A couple of the timber windows are difficult to close and lock. These Windows will need to be adjusted by a carpenter.

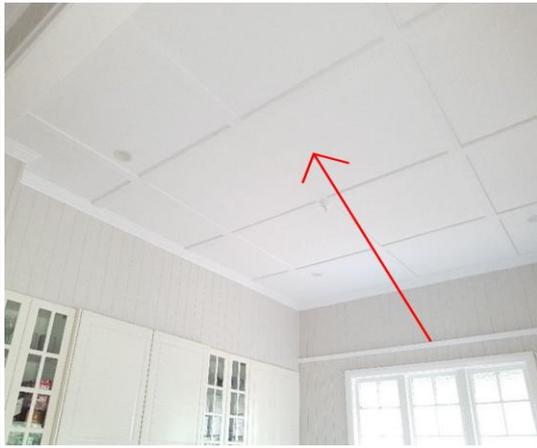
#### ASBESTOS-

The fibro sheeting to several areas to the building may possibly contain Asbestos particles.

Asbestos fibro is safe when it is in situ as long as it is kept painted and not broken or sanded that can in any way make the fibres airborne and able to be breathed in. The dust particles from asbestos can be harmful to your health if breathed in.

If the Fibro is to be removed it is recommended to have a person that is trained in removal of asbestos to carry out the work.

Seek further advice from a Licensed person.

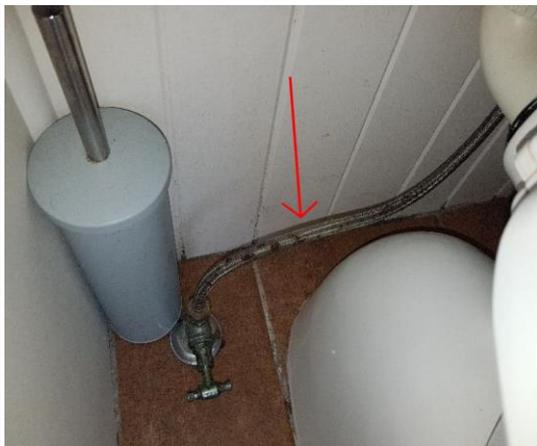
#### FLEXIBLE HOSES-

Toilet.

There are brown rust marks starting to develop on the Stainless Steel braiding on the flexible hoses that are connected to the taps inside the cupboards.

**IT IS HIGHLY RECOMMENDED TO HAVE THE RUSTING FLEXIBLE HOSES REPLACED IMMEDIATELY BEFORE THEY SPLIT.**

Have Plumber inspect the other hoses to the remainder of the taps in the house to confirm that they are in a sound condition.

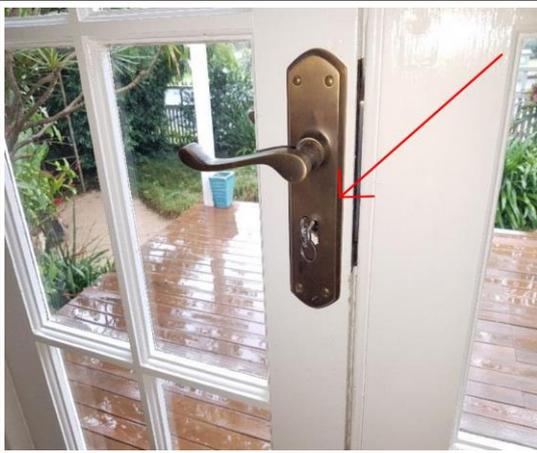
The lock on the French doors in the office is difficult to operate. The Lock will need to be adjusted.

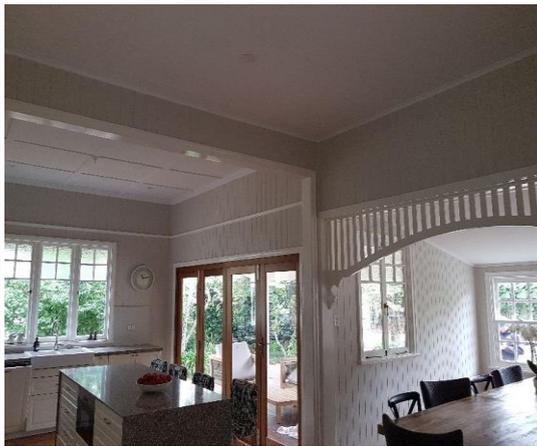
**WEAR AND TEAR-**  
There are normal wear and tear marks throughout the building that is to be expected. This can include minor dents to the walls, hairline cracks to the VJ walls and ceilings, dirt marks, ect throughout the building on the internal walls and ceiling. This is FAIR for a house of this age that has been lived in. Not all defects have been noted in the report due to being minor defects.

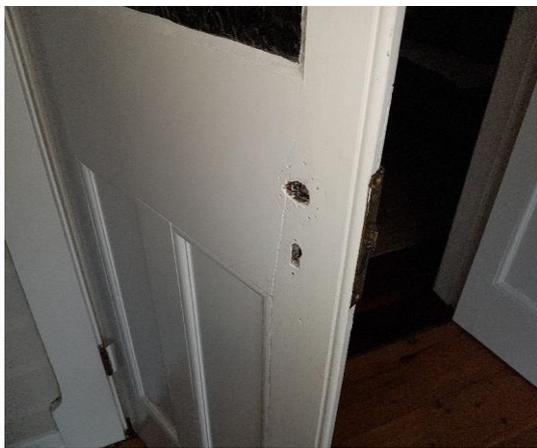
The lock is missing from the internal French doors to the office.
