Report No: 36065

PRE-PURCHASE TIMBER PEST DETECTION REPORT

NAME OF CLIENT : **David Snow c/- Peter Snow & Co**
ADDRESS OF CLIENT: **196 Margaret Street**
TOOWOOMBA CITY QLD 4350
ADDRESS OF PROPERTY INSPECTED : **92 Lindsay Street**
EAST TOOWOOMBA 4350

DATE OF INSPECTION : **01/05/2019** DURATION OF INSPECTION : hrs mins

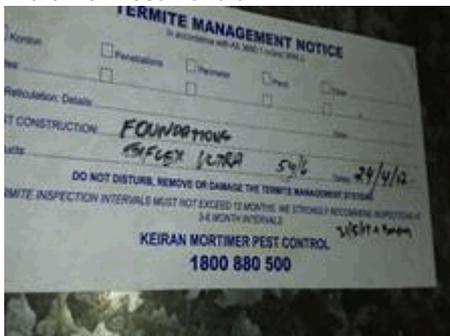
Termite management system in place is current. Last update to the system was 31/05/17. Installed by Keiran Mortimer Pest Control.

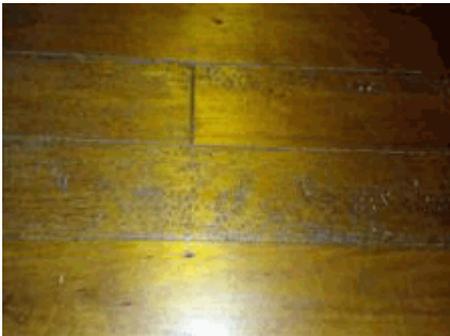
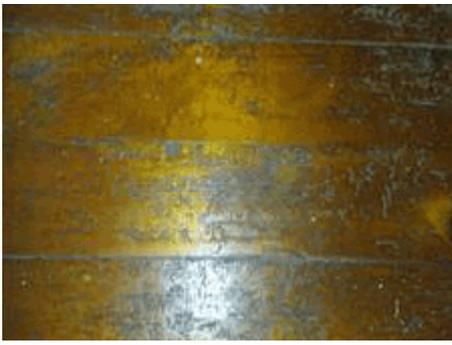
The Wood Borer is believed to be: **Anobiid Borer - see Details below**

The extent of any visible damage appears: **Widespread - see Details below**

Location - Borer evidence to hoop pine floorboards, which is conducive to the age of the property. Monitor and replace as necessary. Treatments can be done. Pest Controller

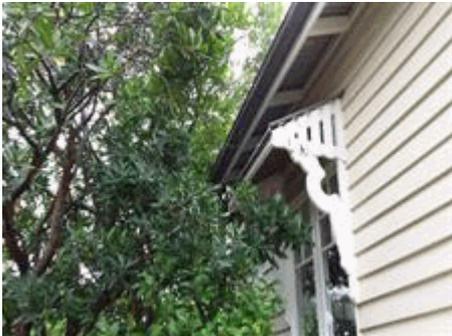
Yes - see Details below, Clauses A.7 and A.8 - Keep vegetation trimmed of the house.

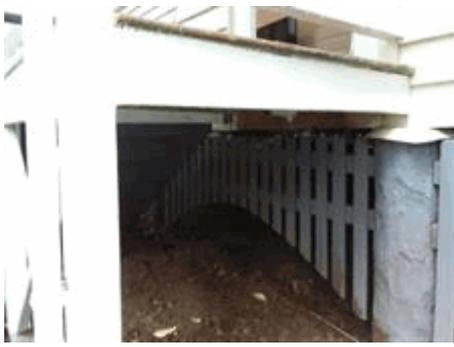
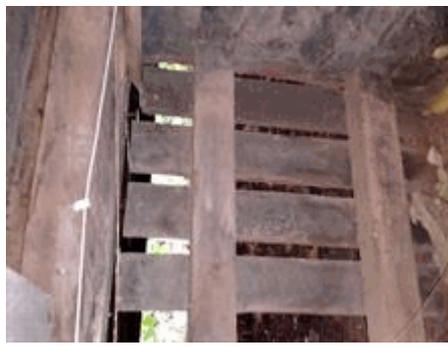
Verandahs Trellis/Fences - Subfloor pailings in contact with the soil and within the recommended 75mm clearance. These need to trimmed off at the top to achieve 75mm gap.

Details - Front porch abutts the house over the ant capping which could allow hidden access by termites. Regular inspections recommended.

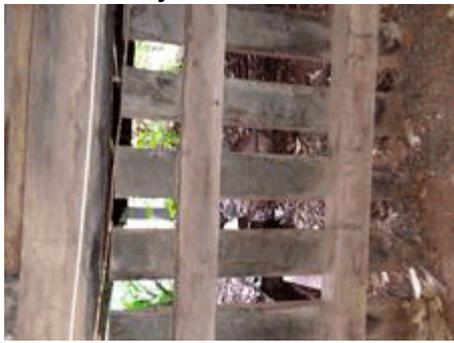
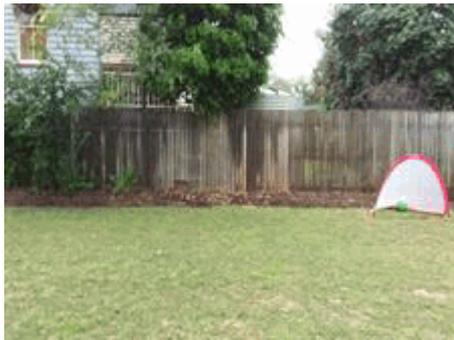
Trellis/Fences

Was evidence of untreated or non-durable timber used in a hazardous environment found? **Yes - see Details below, Clauses A.7 and A.8 - Subfloor pailings and timber fences are termite susceptible. Monitor and replace as necessary.**

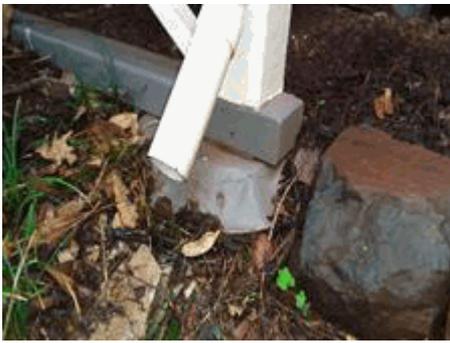
Was evidence of any other condition conducive to timber pest attack found? **Yes - see Details below, Clauses A.7 and A.8 - Soil level at front porch is to close and covering the ant capping. It is recommended for the soil level to be 75mm below the capping.**

Location - Timber in subfloor is termite susceptible. Recommend removing.

- Open ended down pipes should be plumbed or diverted further away from home.
- Timber in subfloor should be removed.
- Ensure trees are trimmed back and that gutters are free from leaf debris.

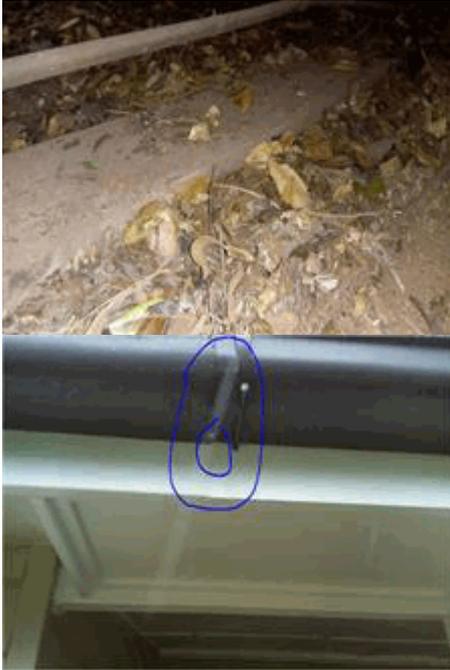
- A leak to a join in the gutter at the back of house can cause moisture build up, which can over time attract termites to the area. Recommend repairing gutter.

Building Contractor - Refer to gutter leak.
