STANDARD TIMBER PEST DETECTION REPORT

Service Order ID:	402665388	Location ID:	421112463
Pre-Inspection Agreement No:		Report No	01
Account Client:	Sue Ung	Client No:	1326575
Address of Client:	36 Twelfth Ave	PO Number	
Client Post Code:	4067	Client Suburb	Saint Lucia
Client email:	susanung@bigpond.com	Client phone	073871 3021
Address of property inspected:	36 Twelfth Avenue	Policy #	
Post Code of property inspected:	4067	Suburb	St Lucia
Date of inspection	26 Sep 2018	Claim Number

A STANDARD TIMBER PEST INSPECTION REPORT - Visual inspection as per AS 4349.3.

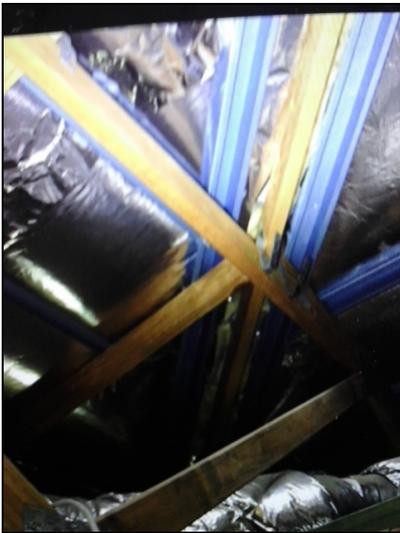
- Roof Space

Photo Notes: Access to the roof void was inaccessible due to foil sarking insulation not allowing for safe access to the roof void, which is a work health & safety requirement.

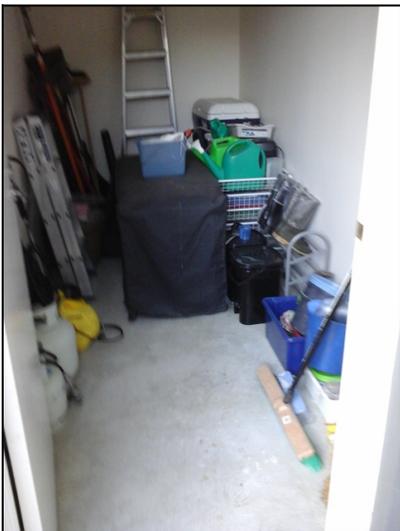
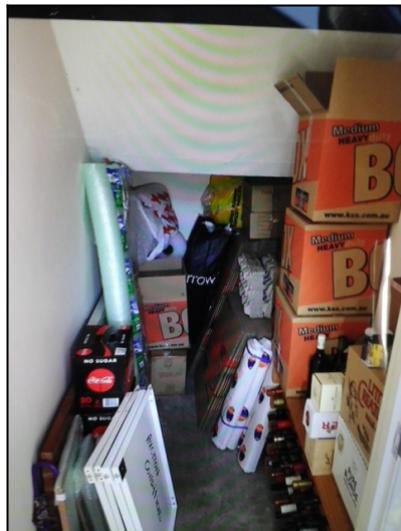
- Furniture
- Stored Items
- Personal Effects
- Floor Coverings or Carpets
- Wall Hangings
- Curtains or drapes

- air con machinery

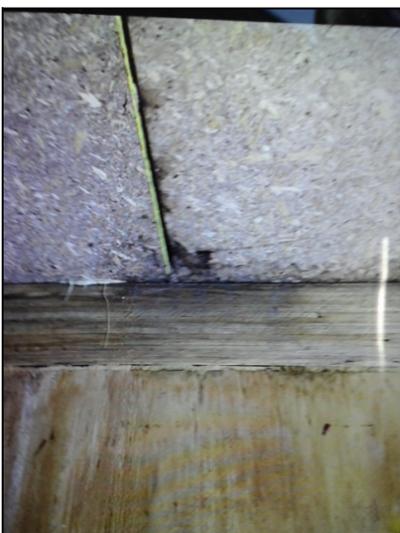
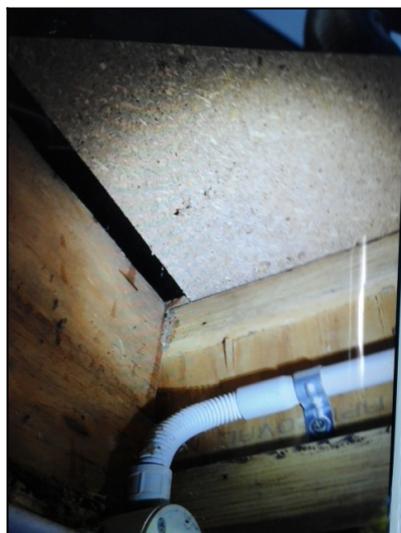
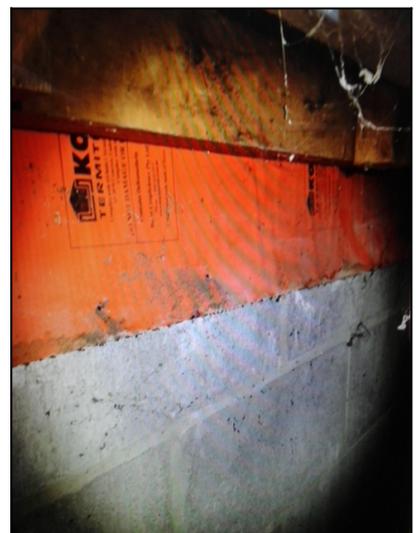
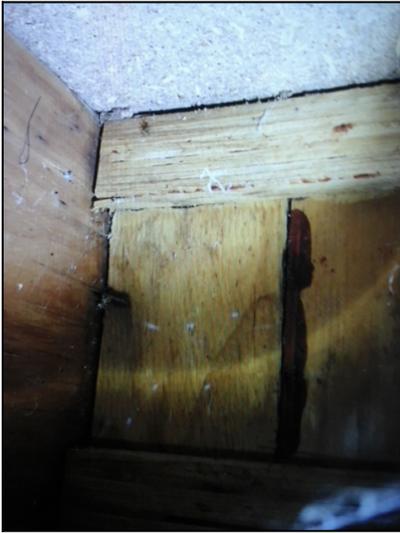
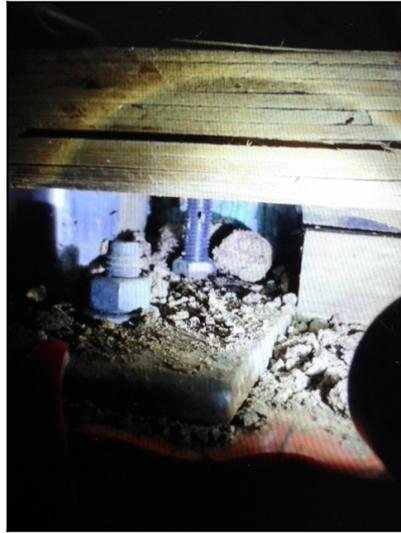
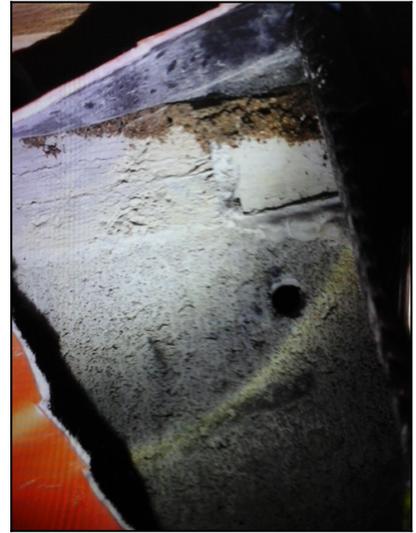
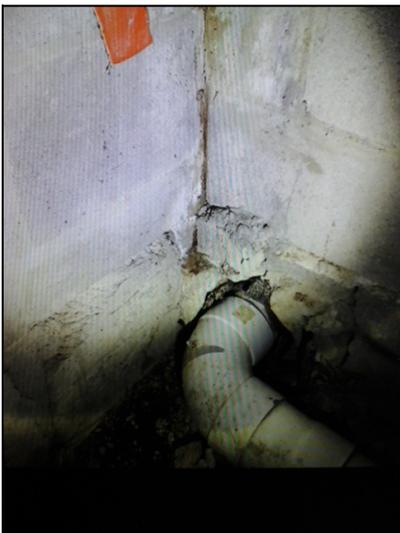
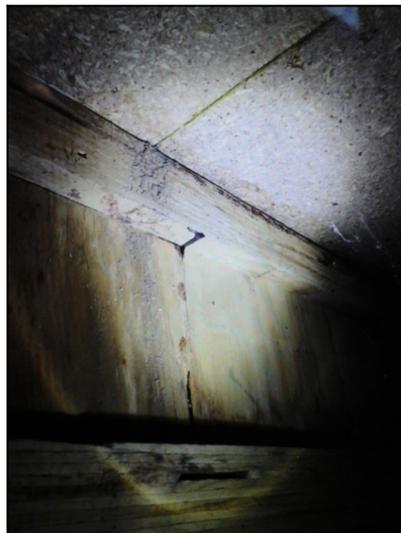
Photo Notes: Subfloor area

- timber damage

Localised

superficial

N.a, treatment was carried out to areas where physical barrier was breached

IMPORTANT: Where evidence of damage to building timbers exists, competent advice (e.g. from a licensed builder or architect) should be sought to determine the extent of any structural damage and to ascertain if any rectification or repair work is needed

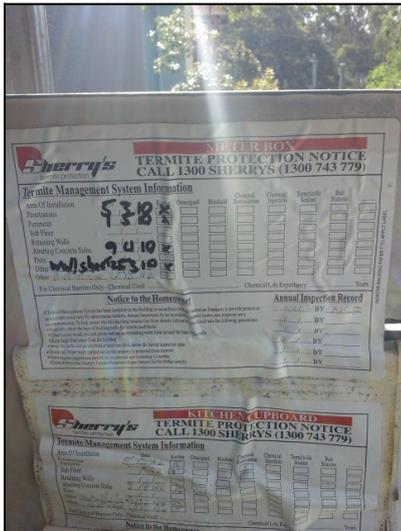
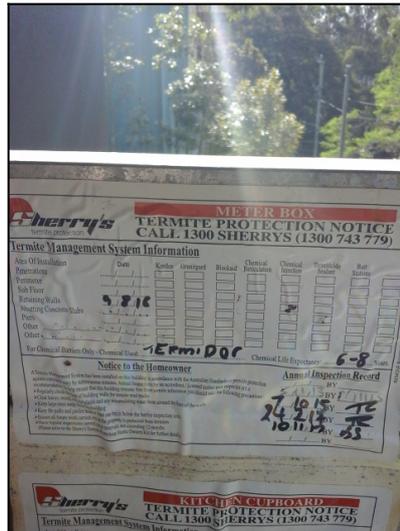
Photo Notes: Kordon installed to service penetrations, perimeter, wall sheeting, snt capping, abutting slabs.. termidor treatment in 2016 to breached areas

Notice in meter box

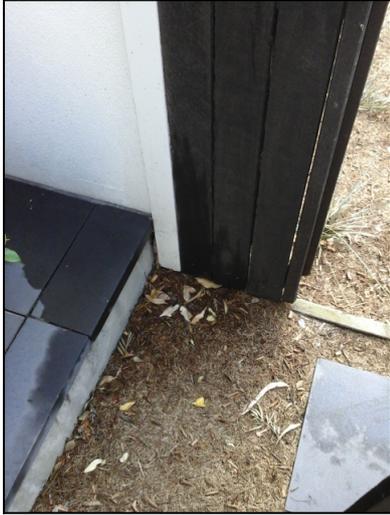
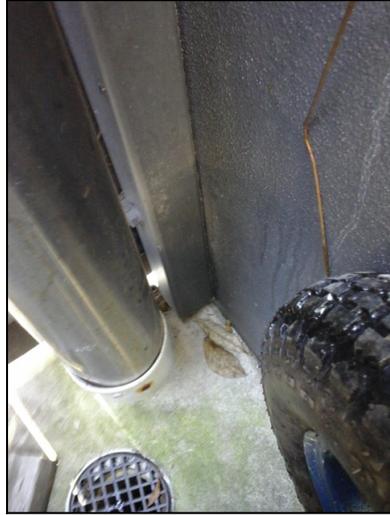
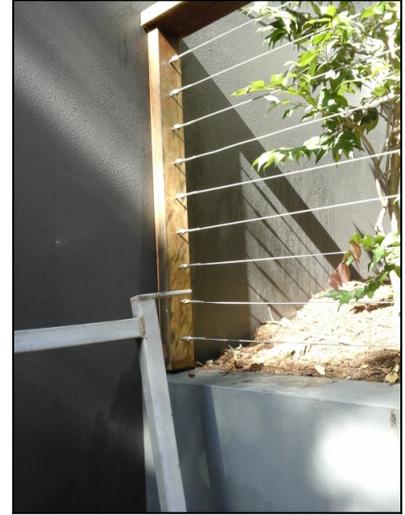
Trellis fences

Yes

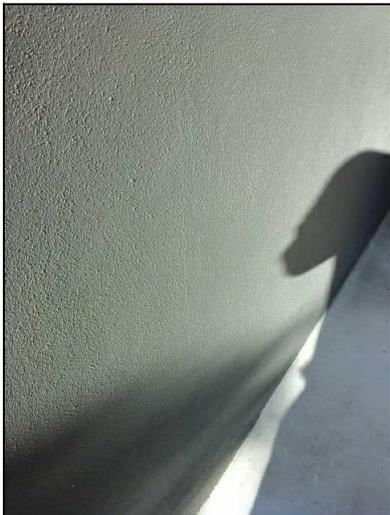
Wall rendering is concealing the physical barrier

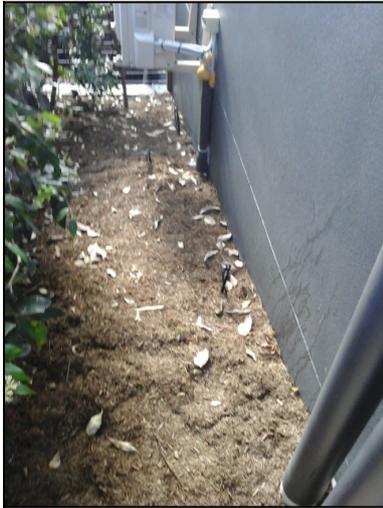
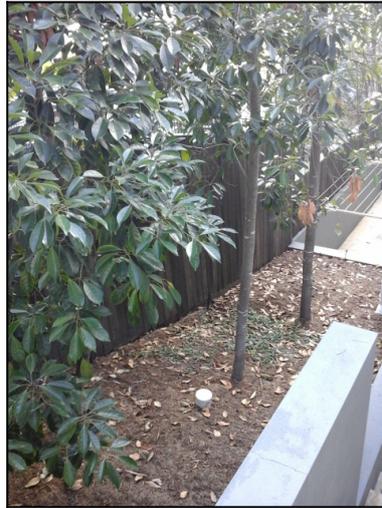
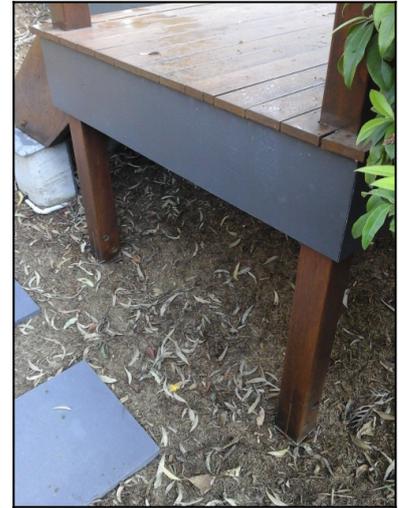
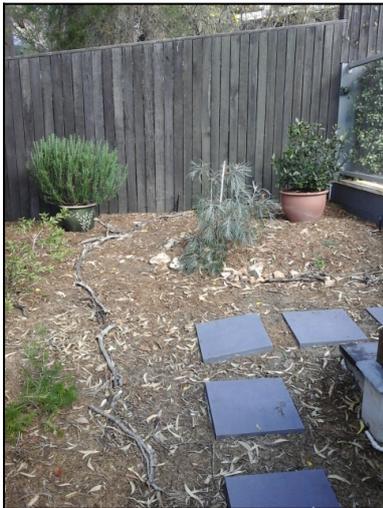
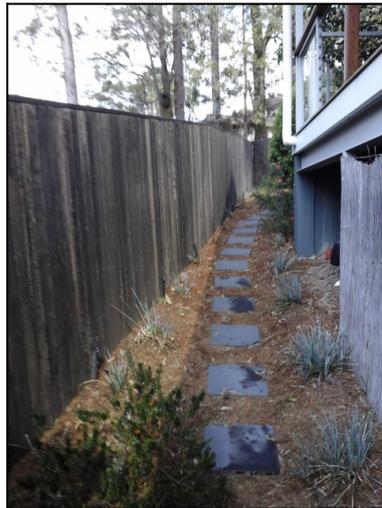
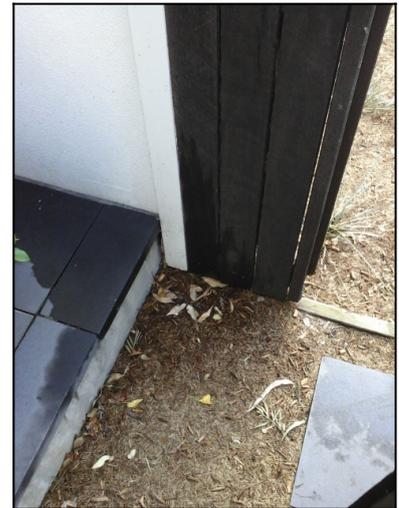
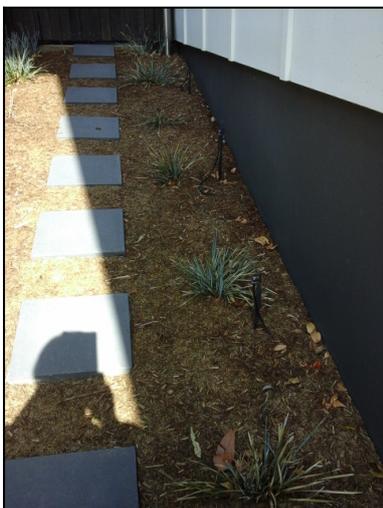
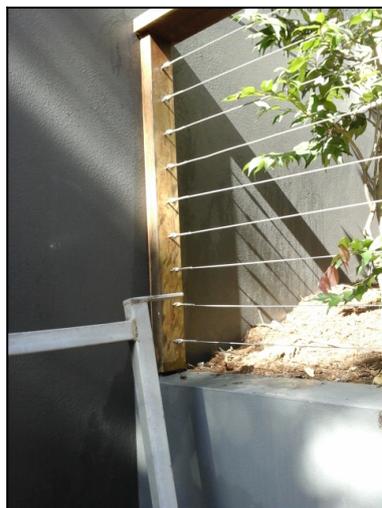
Yes - timber in contact with ground (posts, fencing, foundation piers, timber cladding / firewood or stored timber adjacent to building / firewood, stored timber or other items or materials containing cellulose in subfloor or close to building)

All timber inground contact must have 75mm clearance from ground and no Timbers abutting external walls.

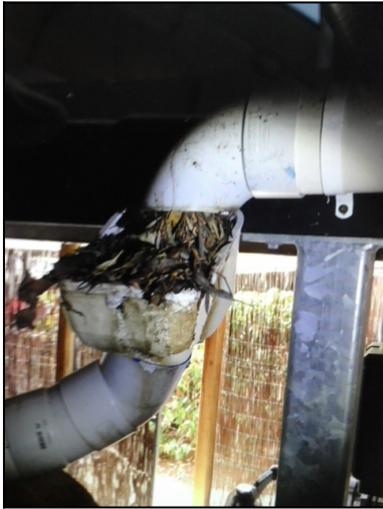
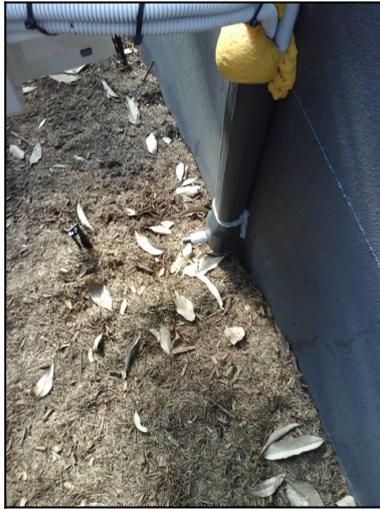
Air conditioner overflow drains against the structure on south west side...water tank catchments are both blocked resulting in rain water ponding in subfloor
