# Residential Building Inspection Report

Complies with Australian Standard AS 4349.1 - 2007 Inspection of Buildings Part 1:  
Pre-Purchase inspections – Residential buildings – Appendix “C”

36 Twelfth Avenue  
St Lucia. Qld. 4067

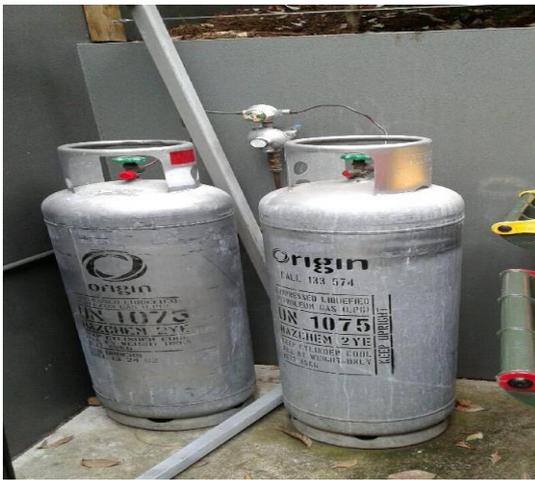
LPG gas cylinders have not been adequately restrained in accordance with AS5601.1. If cylinders are knocked or blown over, gas line may rupture and release gas. This condition is considered potentially dangerous. A further investigation by a licensed gasfitter is strongly recommended to secure the cylinders. The above recommendation should be implemented as a matter of urgency, immediate action must be taken to ensure that anyone entering the area is warned of this hazard.

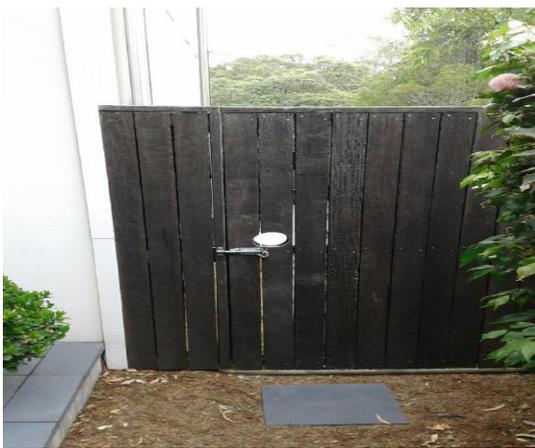
Left elevation - The gate on the left elevation is binding and requires adjustment. – Consult a carpenter for advice.

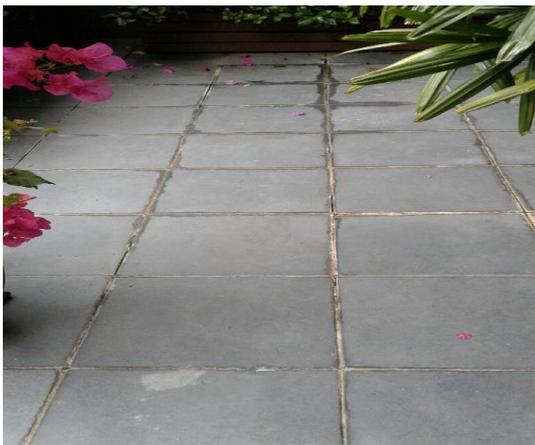
Left elevation- There is efflorescence/salt attack to the pavers to the patio area. This is a normal process of wetting and drying to brickwork, however long-term efflorescence may deteriorate the grout should be monitored, if concern arises a specialist in water proofing should be consulted.

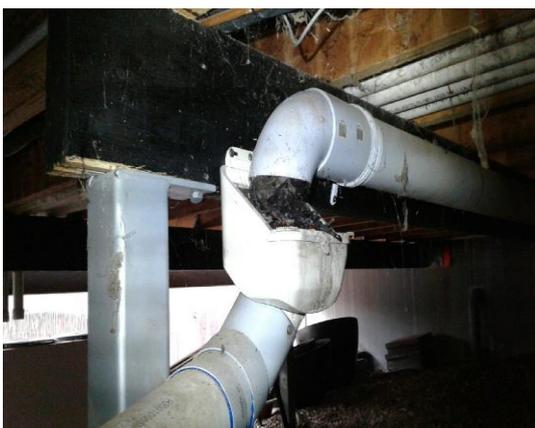
Subfloor- downpipes connected to the tanks are full of leaves and debris. Clearing out leaves may be a consideration

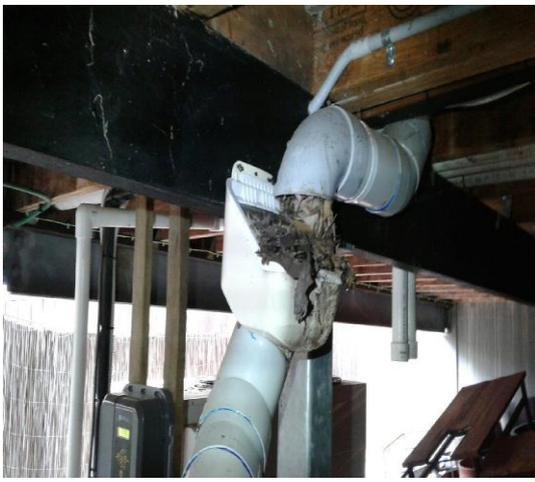
Subfloor- downpipes connected to the tanks are full of leaves and debris. Clearing out leaves may be a consideration

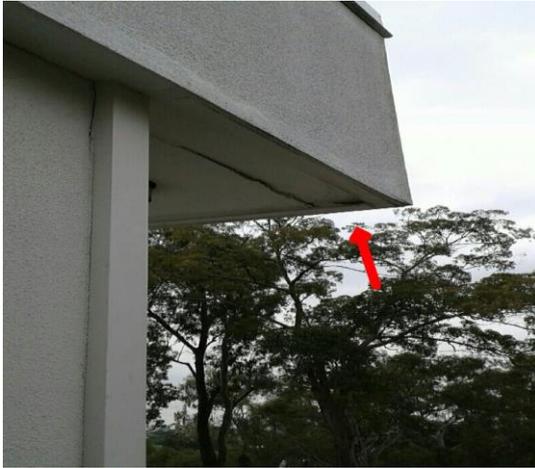
Left elevation- There is evidence of a previous water staining/damage to the soffit lining. I recommend consulting a licensed roofer for advice

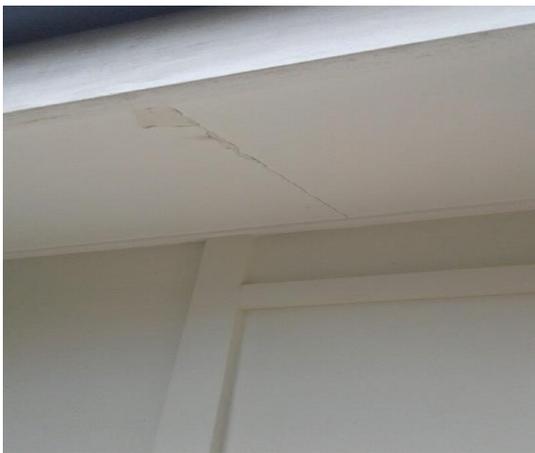
Right elevation- There is evidence of a previous water staining/damage to the soffit lining. I recommend consulting a licensed roofer for advice

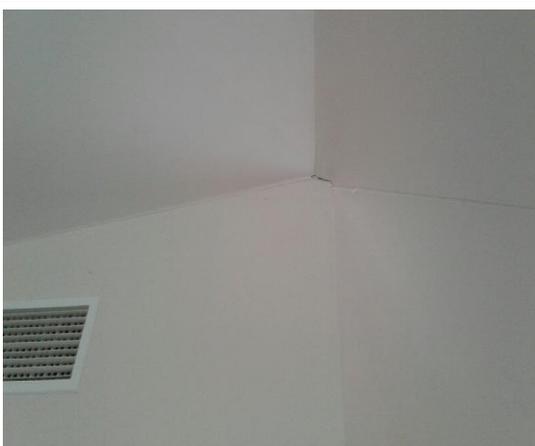
LOUNGE	Safety Defects Found	Not Applicable	Acceptable Condition	Defects Present	COMMENTS
Doors			✓		
Walls			✓		
Windows			✓		
Ceiling				✓	There is some movement cracking long the 'cornice line' of to the ceiling lining. This was not considered structurally significant at the time of our inspection, rather a cosmetic matter, and repairs required are minimal
Floor/Tiles/Carpets			✓

Lounge- There is some movement cracking along the 'cornice line' of to the ceiling lining. This was not considered structurally significant at the time of our inspection, rather a cosmetic matter, and repairs required are minimal

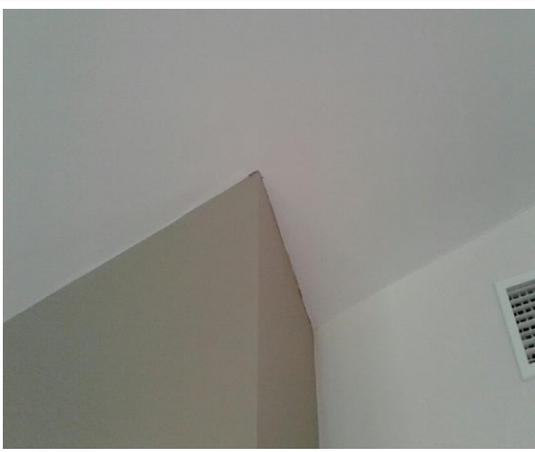
Lounge- There is some movement cracking along the 'cornice line' of to the ceiling lining. This was not considered structurally significant at the time of our inspection, rather a cosmetic matter, and repairs required are minimal

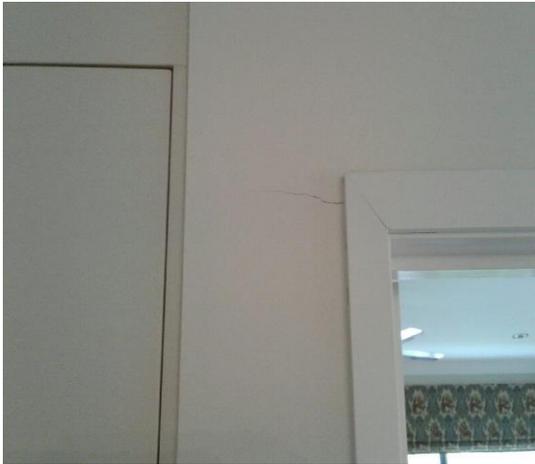
Hall/Study- There is minor cracking to the plasterboard adjacent study door opening. Minor plaster repairs are required.
